X-RAY BRAVI ALPHA The Fin Installation

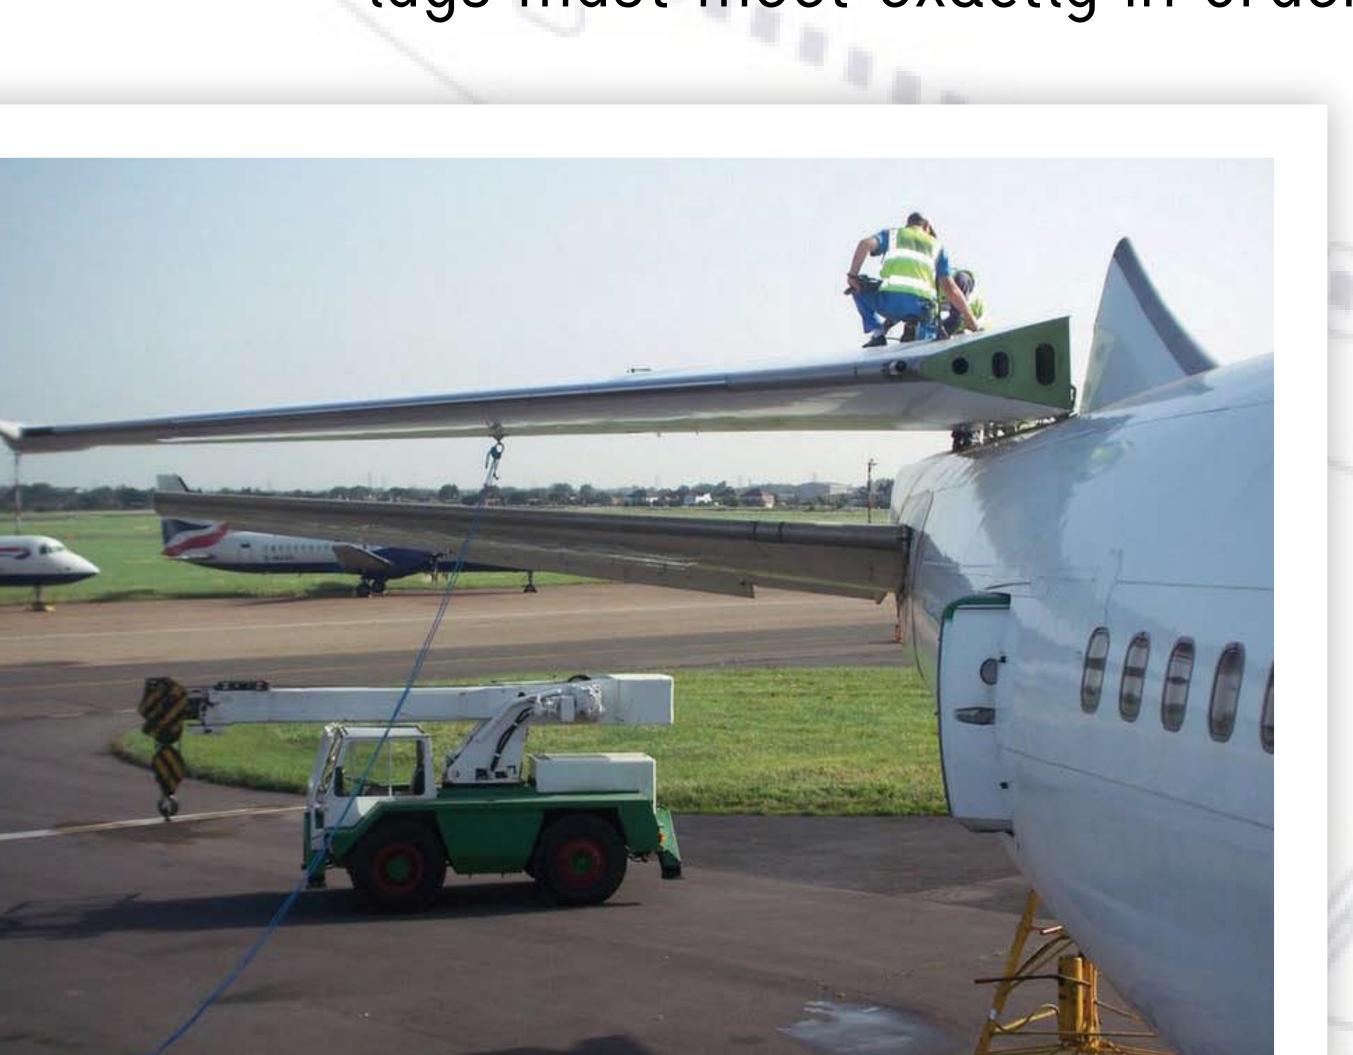
...the smiles are back on many peoples' faces, the biggest of which belongs to Peter.

At this point, attached by the right side pins but still horizontal, our fin is held level by the crane but a jury strut has to be installed to hold it so, while the crane is disconnected.

Again, a few deft movements with the required links and the strut is in place and we hold our breath while the crane jib is lowered and the cables go slack, the strain now taken by the bright red strut.

Next, the fin has to be raised through 90 degrees to the vertical position and the left

mounting pins installed.

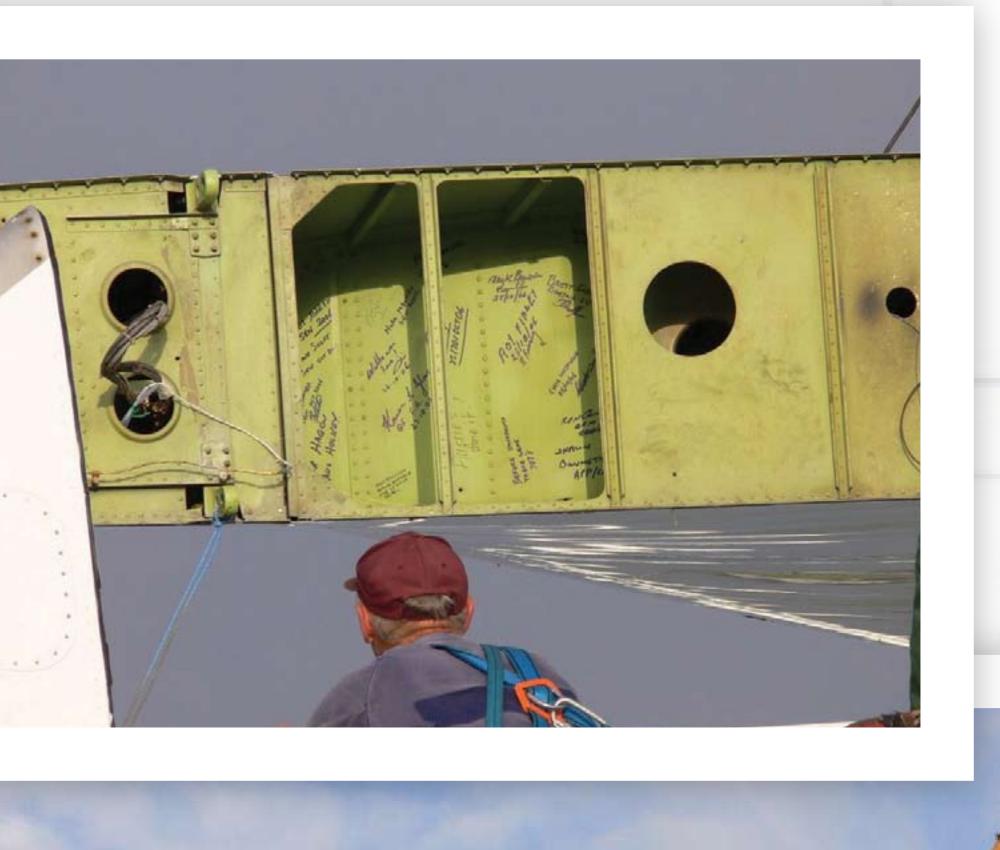
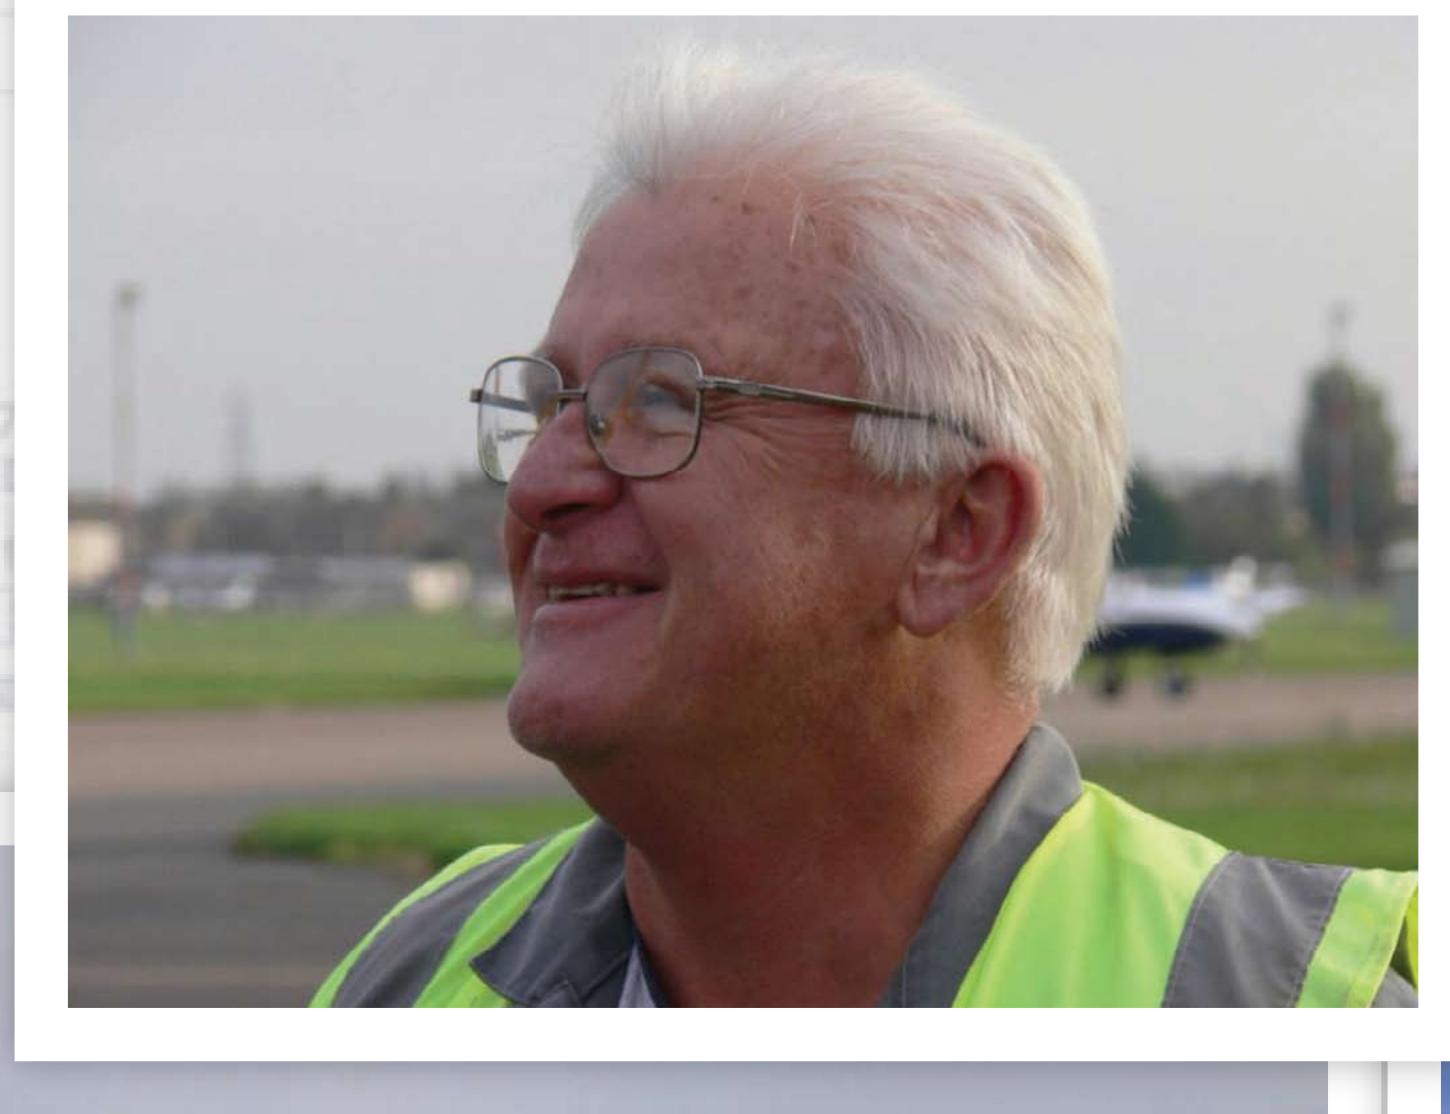
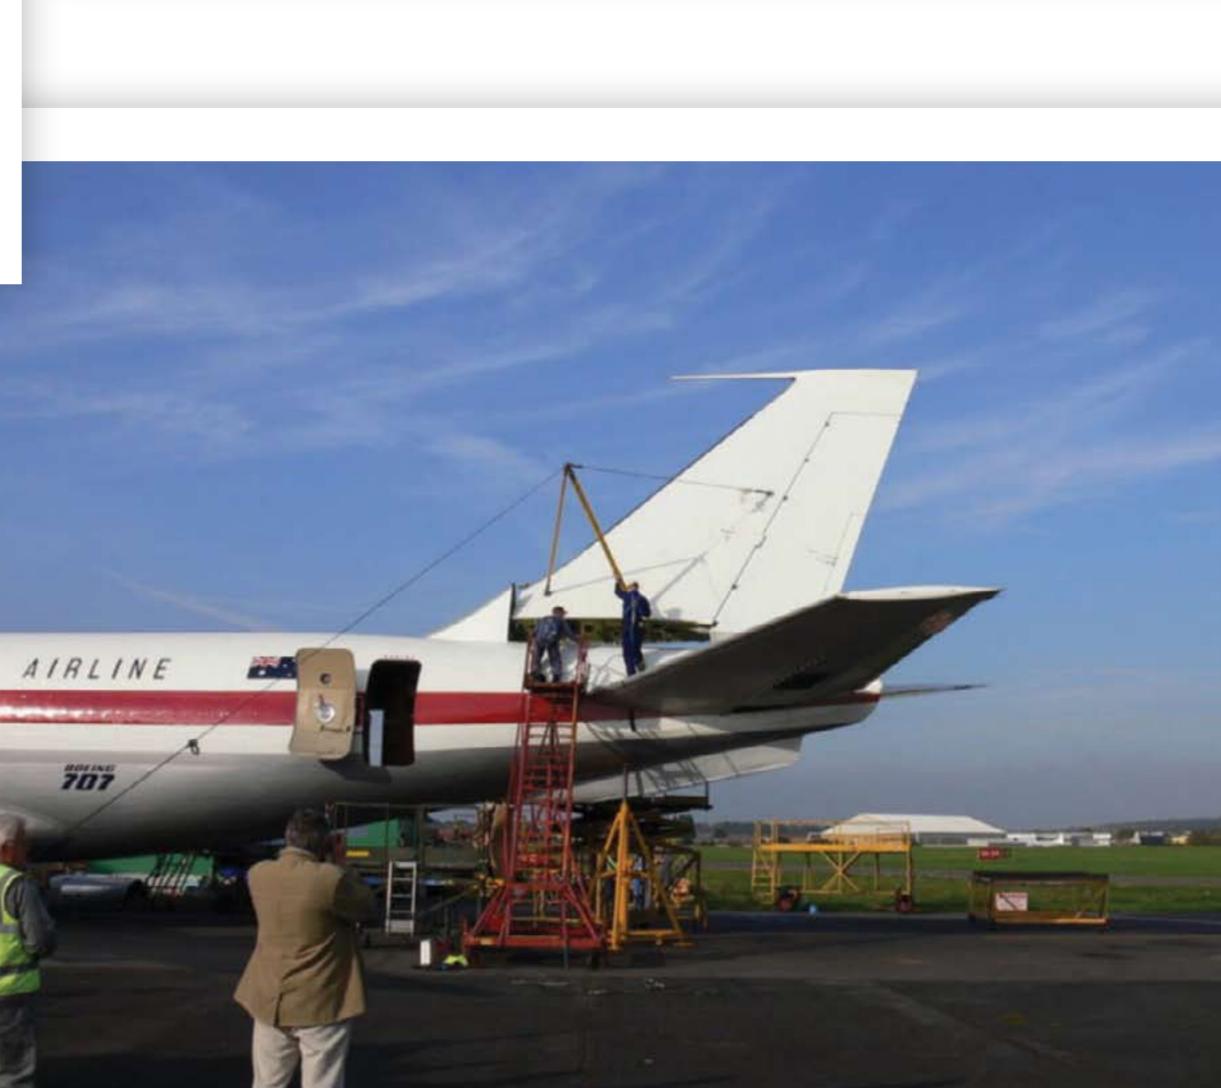
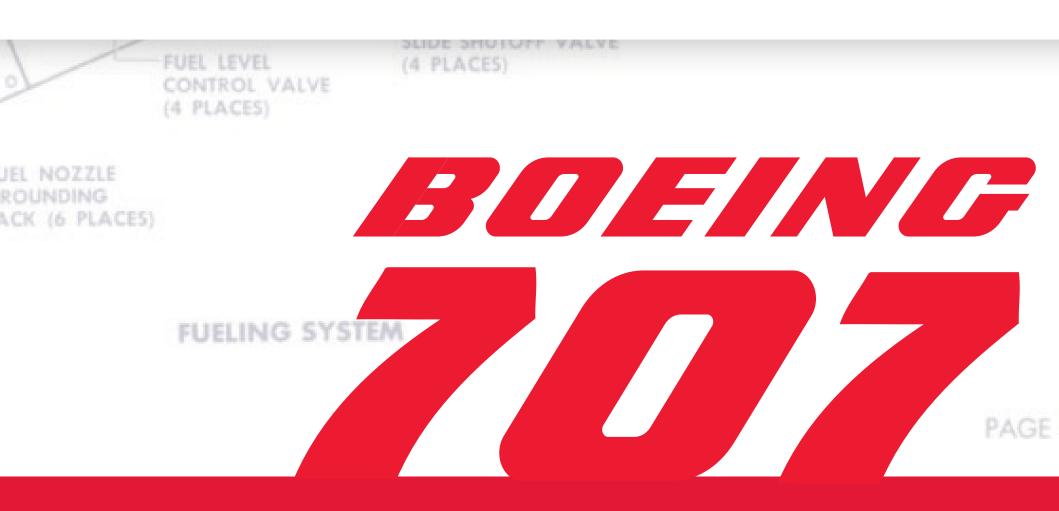
6 September 2006 The Vertical Stabiliser is removed 30 October 2006 The vertical Stabiliser is re-installed.

he inspection of the vertical stabilizer, or fin, showed that corrosion had been at work on a main rudder hinge bracket. There was no way to remove and replace this vital fitting with the fin in place. The only option was to remove the 1 tonne surface and do it on the ground.

After rectification of the hinge fitting, the fin was re-installed.

An A frame is erected that will add the mechanism to allow a cable to be connected to the tow bar that will pull the fin up to vertical.

Another pause for breath as a tractor pulls on the cable which tensions up under the weight of the fin as it slowly transfers the strain from the jury strut. When exactly the right force is applied, the strut can now retire.

The tractor creeps backwards and the fin now starts its upwards arc and the gentlest of clunks announces the meeting of the left side lugs. It's up.

The final bolt installation is mere routine and at 0940 the fin is declared bolted in place.
